Transport
Canada

TP 185E
Issue 3/2009

AVIATION SAFETY LETTER

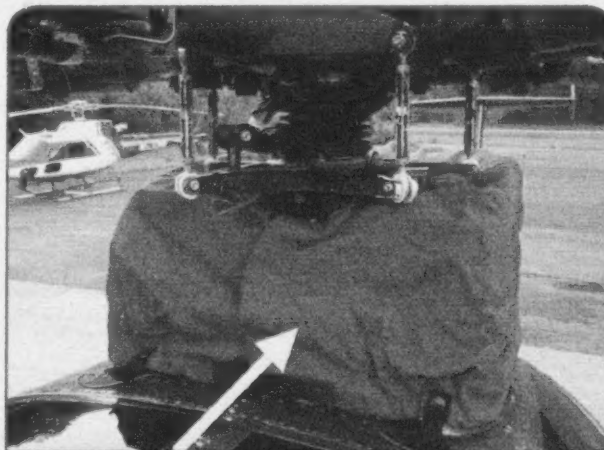
Doghouse cover

The cover did not have any straps or physical barriers that fall at or below human eye level. Once the pilot gets into the helicopter, there are no visual clues of the cover's installation. Before this occurrence, it was expected that the engine would not start with the cover installed, but we now know that as soon as the rotor started turning, the cover opened enough to let in sufficient air for the start.

It is clear that the removal of the cover was missed during flight preparation and that the cover damaged the main rotor controls while the rotor was turning. Also, rotor rpm was likely lost due to the binding effect that the cover had as it squeezed between the stationary and rotating components of the swashplate assembly. This rendered the helicopter uncontrollable after the takeoff, and it collided with terrain.

1. The doghouse cover was not removed before flight and it wrapped around the flight controls linkage, damaged the linkage, and rendered the helicopter uncontrollable.
2. The helicopter fell in an uncontrolled state, with reduced rotor rpm, until it collided with terrain.
3. Anomalies in the pilot's routine and the lack of physical barriers likely caused him to miss removing the cover before the flight.
